MINISTRY OF THE ENVIRONMENT
INDUSTRIAL WASTE SITE IDENTIFICATION STUDY

(Site Investigations)

CYANAMID CANADA - NIAGARA

(Site No.9)

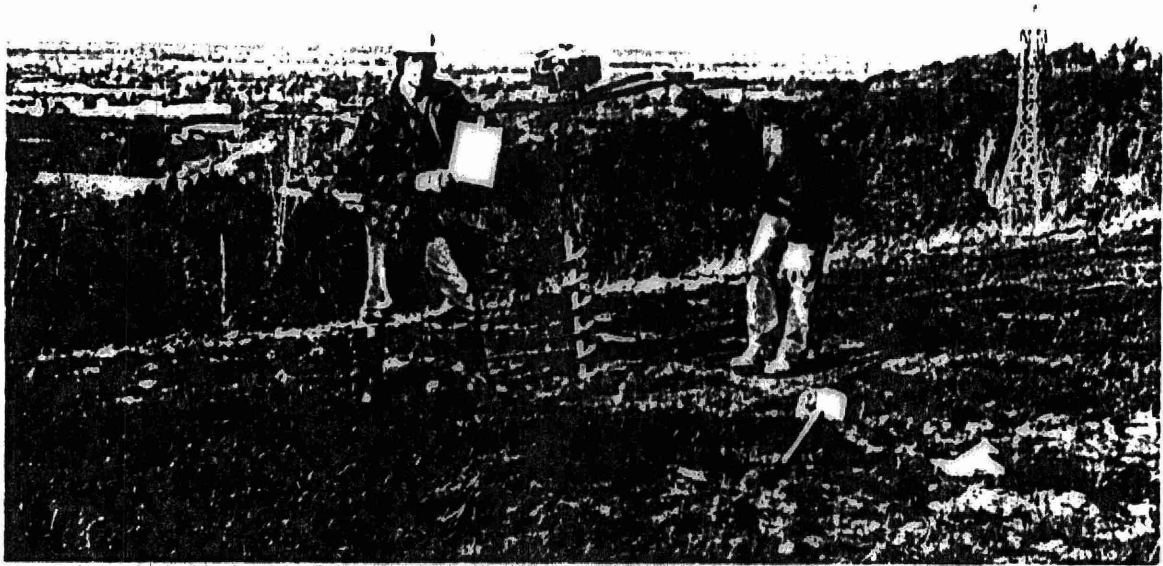
The site, known as the St. Davids Landfill, is located on a west-facing slope of the Niagara Escarpment (see Location Map). A record of a water well (see Water Well Records, No.2346) at about the same elevation as the site reported that 20 metres of interbedded clay, sand, and gravel overlie limestone bedrock.

THE WASTE DISPOSAL SITE OVERLOOKS NIAGARA-ON-THE-LAKE.

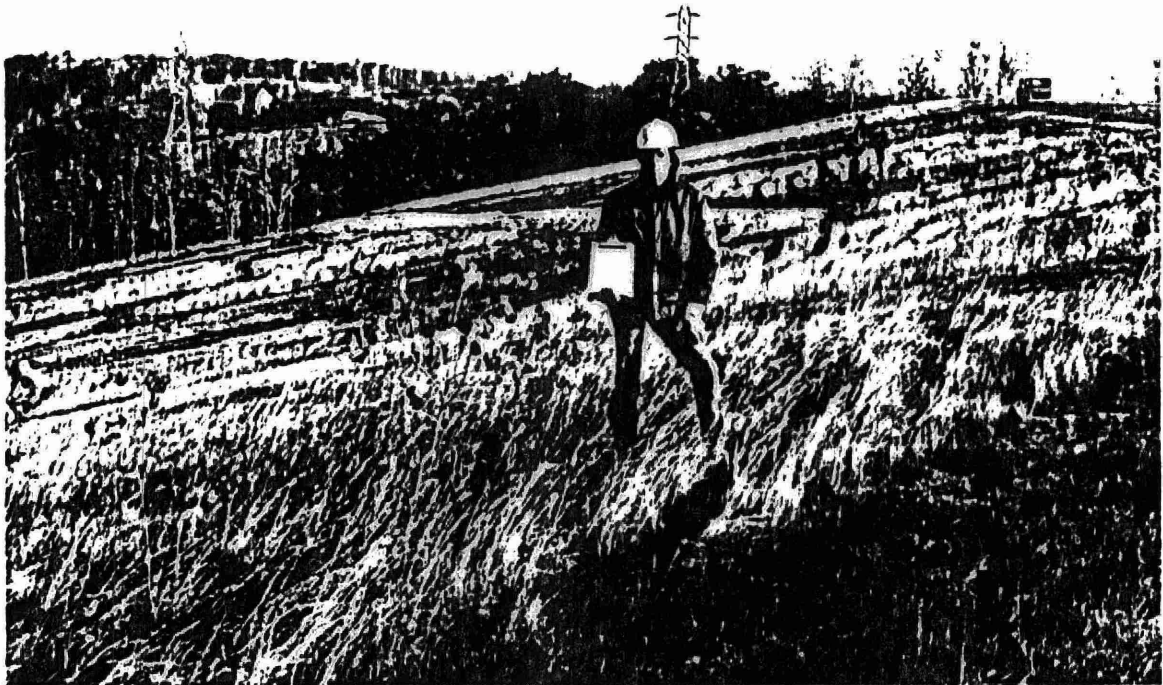
The rip-rap and grass on the landfill slope have provided good slope stability, although there is some erosion near the base of the slope. The death of mature trees at the base of the landfill slope is considered due to root burial by fill (and possibly waste) rather

THE WASTE HAS BEEN COVERED AND STABILIZED WITH RIP-RAP, AND WILD GRASSES NOW GROW ON THE COVER.

Monitoring of the landfill slope stability should continue, and water in the piezometer located at the base of the landfill slope should be sampled and analyzed. Groundwater seeps located at the south-east edge of the northern recharge pond should be re-sampled and analyzed for cyanide. The analytical technique should be capable of detecting cyanide at concentrations less than the Ministry of the Environment's drinking water quality criterion of 0.2 milligrams/litre.

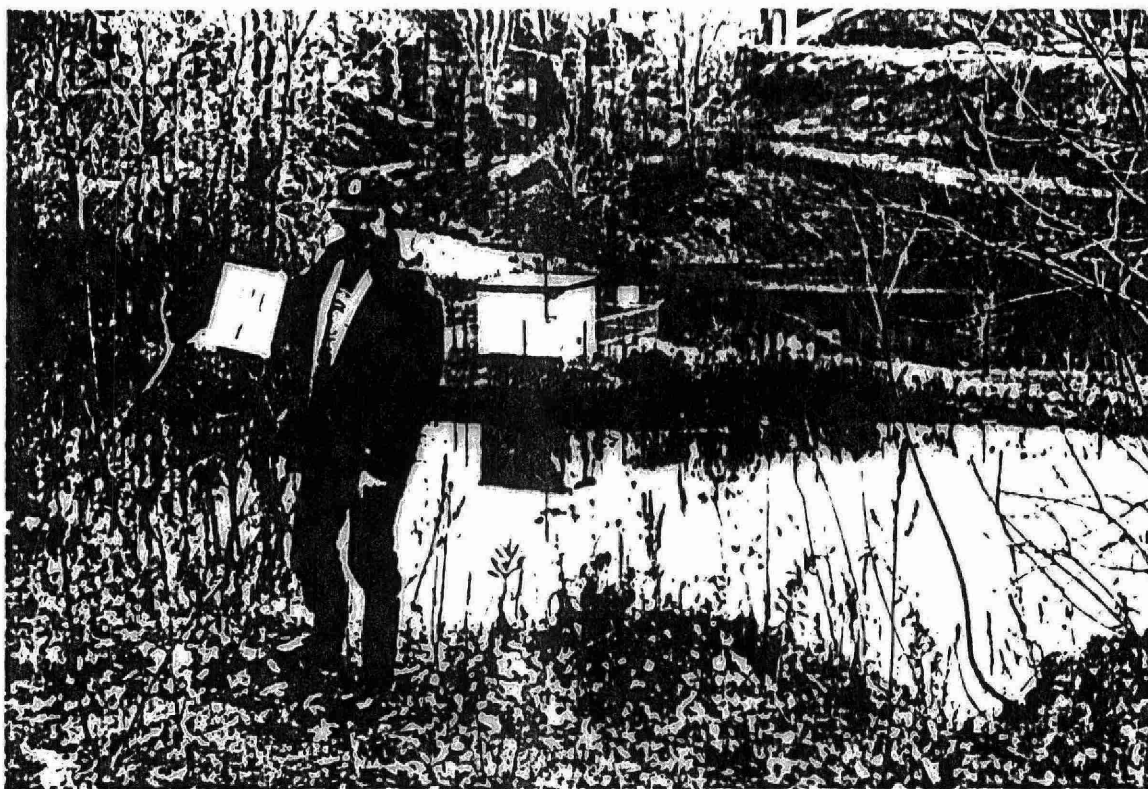
The municipal groundwater supply for Niagara-On-The-Lake is located near the base of the escarpment directly below the landfill. Three recharge ponds are located in the well field. The two most southern ponds are supplied with water from the nearby hydro-electric power canals in order to provide the well field with a continuous supply of water. The well field was initially installed in 1961, and post-dates first use of the St. David's landfill site.

The results of this and previous studies suggest that leachate generated by the waste is affecting water quality in the north-east area of the Niagara-on-the-Lake municipal well field. Silty fine sand at the base of the landfill slope has an ammonia-like odour to a depth of about 18 metres. This indicates that active transport of nitrogen compounds (which have been leached from the waste) is occurring and will continue for many years. Under more oxidising conditions, ammonia would be expected to convert to nitrate, and this may explain the relatively high level of nitrate measured in a small groundwater seep located a few metres east of the northern pond in the well field area. The overburden well (No. 3) closest to this seep reportedly contains higher levels of nitrate than the other wells.

MUNICIPAL WATER SUPPLY FOR NIAGARA-ON-THE-LAKE IS LOCATED NEAR THE BASE OF THE WASTE DISPOSAL AREA. ONE OF THE PUMPING STATIONS AND RECHARGE PONDS IS SHOWN ABOVE.

Monitoring of groundwater quality in the municipal well field should continue as long as the field provides a water supply or is retained as a stand-by source. Also, if the well field is to continue to be pumped or retained on stand-by, the following studies should be implemented:

1. Evaluation of possible long-term effects on well water quality from leachate production and migration.
2. Methods of minimizing or controlling leachate production and migration.
3. Determination of availability of alternate water supplies or water treatment processes if well water quality should deteriorate beyond acceptable levels.

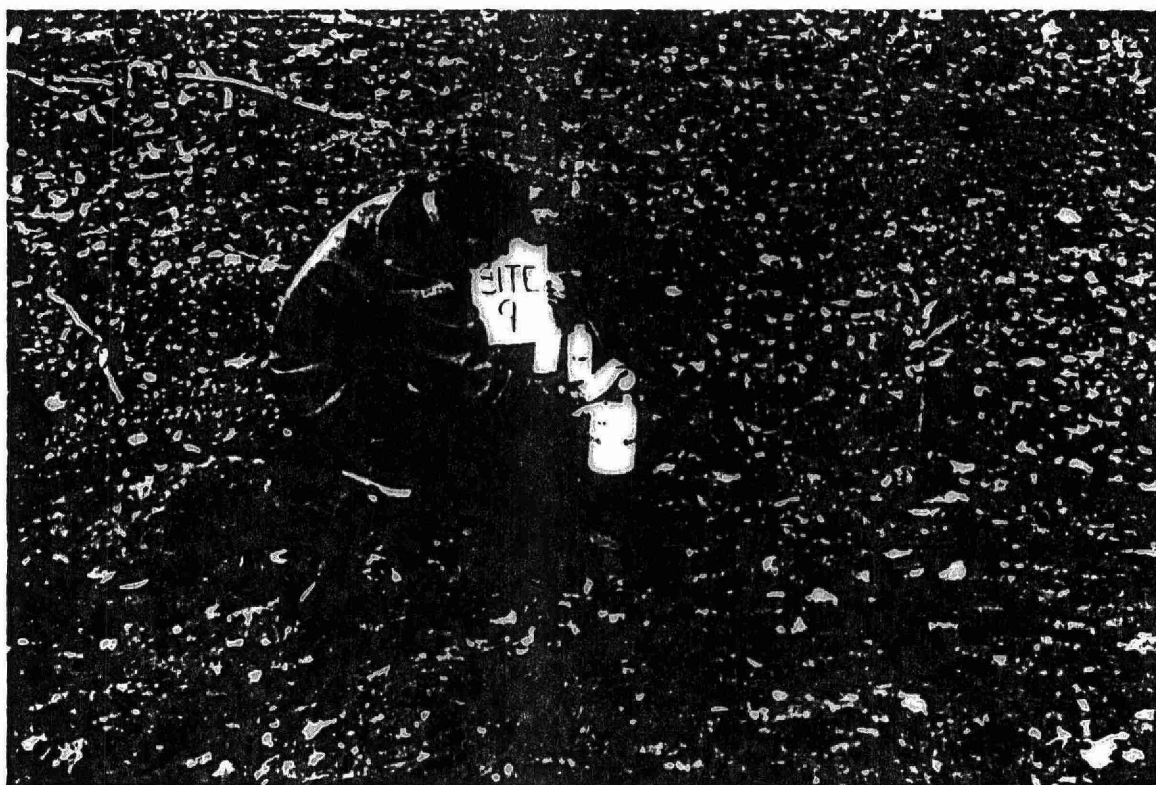
Mr. A. Smith reported that the northern pond (known as Pond No.3) is fed by small groundwater seeps located around the south-east corner of the pond. Concentrations of nitrate (as N) in these seeps has been measured and reportedly found to be generally between 20 and 30 milligrams/litre, in comparison with concentrations of less than 0.2 milligrams/litre measured in the two southern recharge ponds. Water from the municipal well (known as Well No.3) located approximately 40 metres south-east of the Pond No.3 reportedly contains greater concentrations of nitrate than the other municipal wells. In addition, Well No.3 has recently become encrusted with calcium carbonate deposits, whereas the other wells have not. Well No.3 is approximately 18 metres deep, and is finished in the overburden. Because of these observations, it has been suspected that the St. David's landfill site is affecting water quality of part of the well field. The Ministry of the Environment has recognized this for several years, and is monitoring quality of the water supply.

Samples for more detailed analyses were also collected from the ponds, as well as from a small groundwater seep located a few metres east of the northern pond (Pond No.3) and from Municipal Well No.1 cyanide was not detected (i.e. less than 0.5 milligrams/litre) in any of the samples. Nitrate (as N) in samples from the seep (No. GW2) and from Pond No.3 exceeded the Ministry of the Environment's drinking water quality objective of 10 milligrams nitrate (as N)/litre.

A GROUNDWATER SEEP NEAR A RECHARGE POND WAS SAMPLED.
